Sea Captain Marine Surveyor Inc.

Pre-purchase Survey – (Enter Client's Name) October 2025

1. Vessel Overview

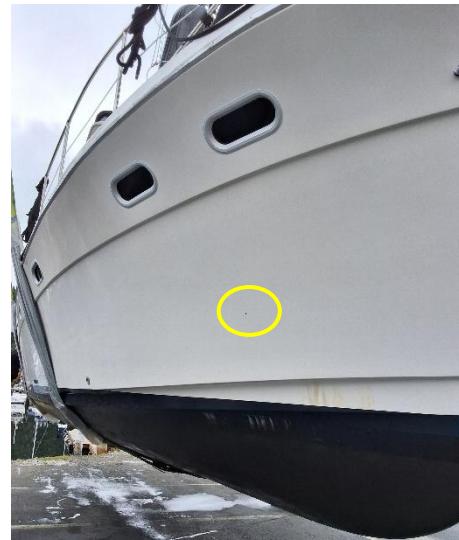
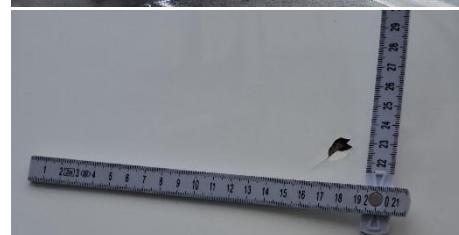
Bow Condition: Small, localized impact on starboard bow approximately 50 mm x 50 mm (2.0 in x 2.0 in), located 0.76 m (2.5 ft) above the waterline and 1.52 m (5 ft) aft of the stem. Damage cosmetic in nature; no moisture intrusion detected. See picture 5 and 6. * See recommendation C-1.

Picture 5 and 6: Starboard bow impact affecting gelcoat.

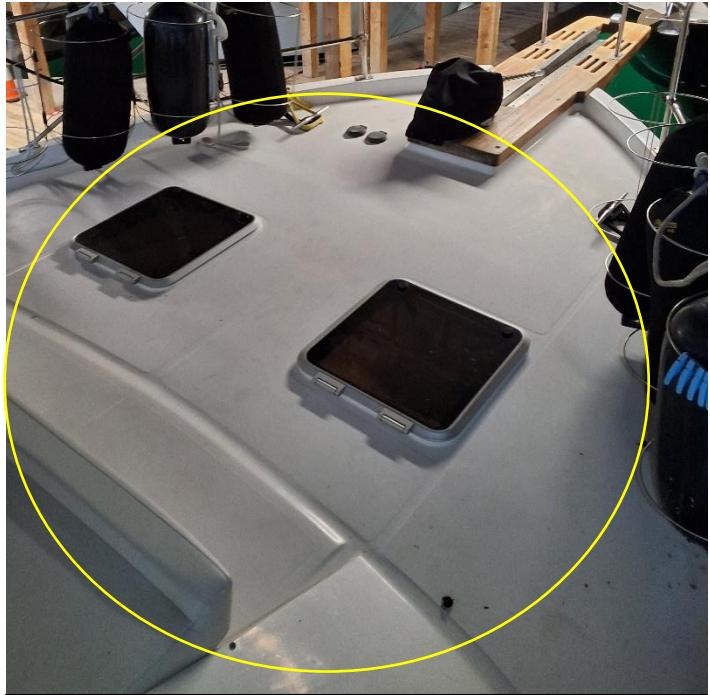
Deck Moisture: Localized softness detected across the forward deck area, extending from the bowsprit to the bow seating platform and spanning from the port side to the starboard side around both deck hatches.

Moisture readings elevated near the deck hatches, windlass foot switches, and within the bow seating area. The affected region was broad and may extend beyond the visibly softened areas, as moisture migration within cored fiberglass structures can travel further than the initially detected boundaries. High moisture levels were concentrated throughout the forward deck and should be assumed extensive until verified by destructive testing or core sampling. See picture 7. *See recommendation C-3.

Picture 7: Bow deck view showing elevated moisture and soft spot.

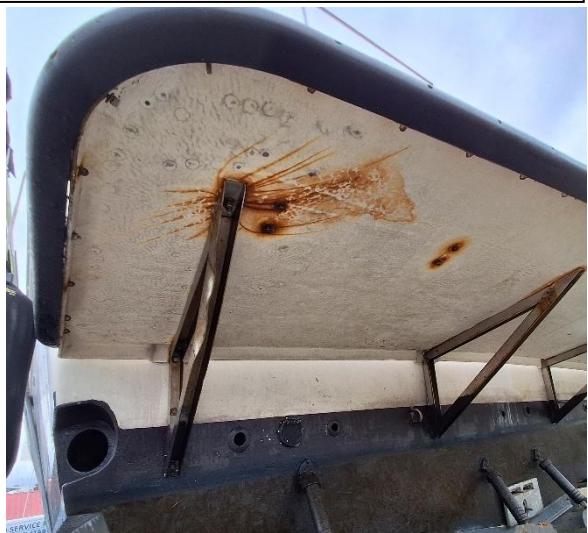
Swim Platform: Molded fiberglass reinforced plastic structure with surface stress cracks of cosmetic nature. Connection points to hull solid; mounting bolts exhibited rust staining. No davit attachments installed. See picture 8. *See recommendation C-4.

Picture 8: Under view of swim grid showing rusty attachment bolts for re-boarding ladder. Also showing FRP stress cracks.

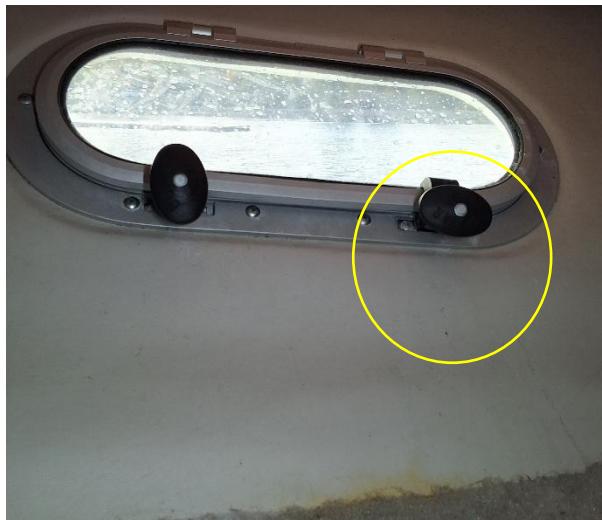
Windows and Portholes: BOMAR windows fitted throughout. No cracked panes but light crazing observed. Seals observed serviceable. Corrosion present on several interior hinges and handles. Starboard bow exterior porthole frames exhibited impact damage and surface scratching near rub rail. See picture 9, 10 and 11. *See recommendation C-6.

Picture 9 (Left): Inside view of port side bow porthole. Rust stain and corrosion visible on aluminum fasteners. Same condition on starboard side portholes. (not pictured)

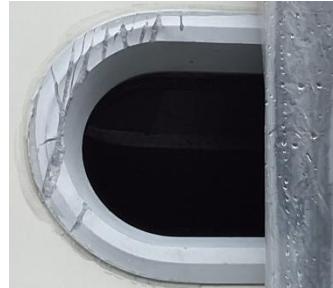
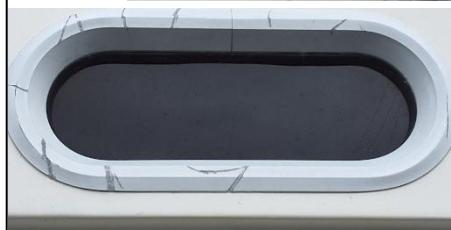
Picture 10 & 11 (Right): Starboard side portholes frame at the bow, outside view. Showing scratches and impact damage around the frame's perimeter.

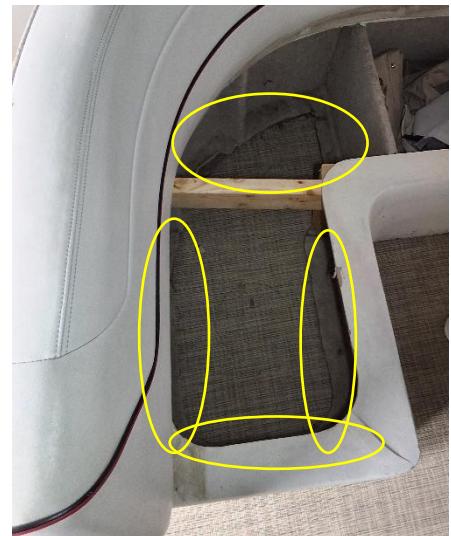
Upholstery: White vinyl upholstery throughout exterior seating. No rips or tears observed. Flybridge starboard seat previously repaired due to frame rot. Port-side seating frame plywood delaminating, primarily aft section. See picture 12. *See recommendation C-8.

Picture 12: Port side flybridge seating with rotting plywood base.

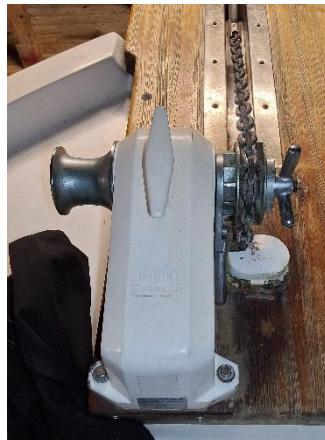
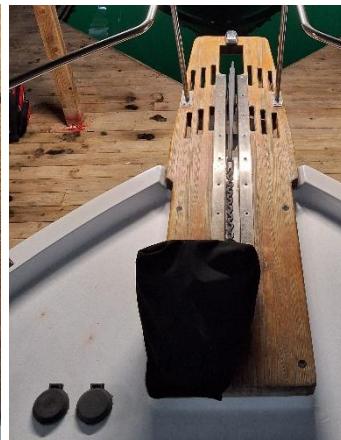
Anchor Windlass: MUIR COUGAR model 4R-77C, serial number 4557. Electric windlass with foot controls at bow. Electrical connections observed intermittent during testing. See picture 12 & 13. *See recommendation B-1.

Picture 12 & 13: MUIR windlass and anchoring system including foot controls (working intermittently), anchor and attachments with bowsprit.

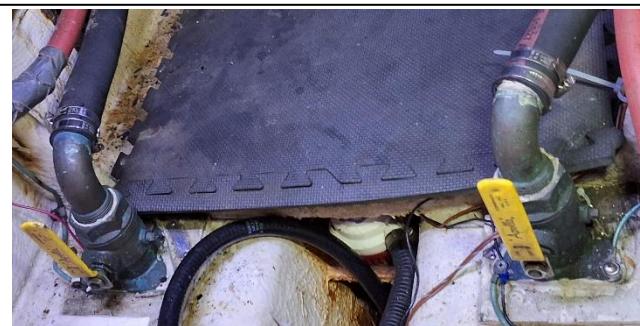
Picture 14: Main engines saltwater intake for cooling system. Double clamped and tested by hand only.

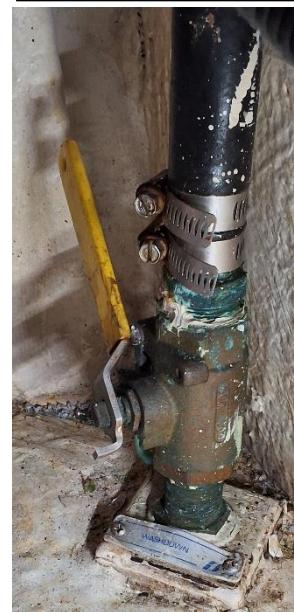
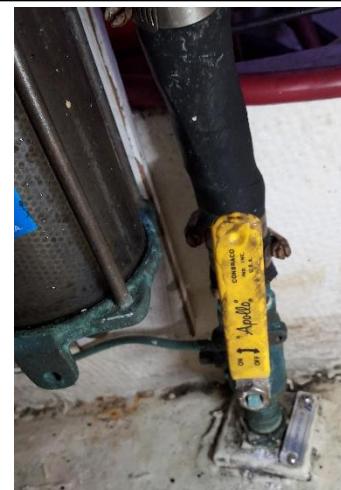
Picture 15 (Left) & 16 (above): Washdown and generator saltwater intakes. Both double clamped and labeled.

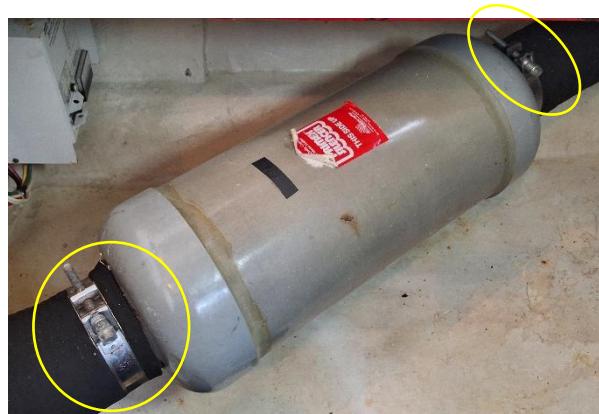
- **Starboard side:** Single stainless steel clamp on each hose connection. See picture 19.
- **Port side:** Multiple cracks visible near heat-exchanger elbow and outer bends; hose soft and folded. See appendix photo 3.

Picture 19: Single hose clamp used at silencer connection.

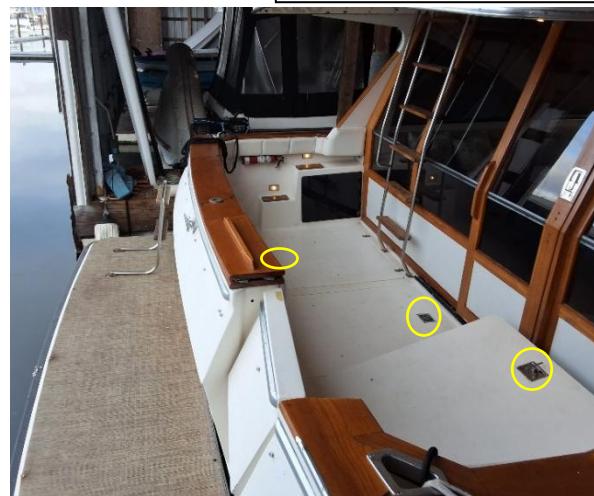
Engine Room: Fiberglass-lined with insulation. Lighting functional. No automatic fixed fire-suppression system fitted. Access hatches—port hatch handle rusted and difficult to operate; starboard lift mechanism seized; mid-hatch handle stiff. Numerous FRP surface cracks present. See picture 21. *See recommendation C-9.

Picture 21: Aft cockpit access hatches (3) with damaged handles.

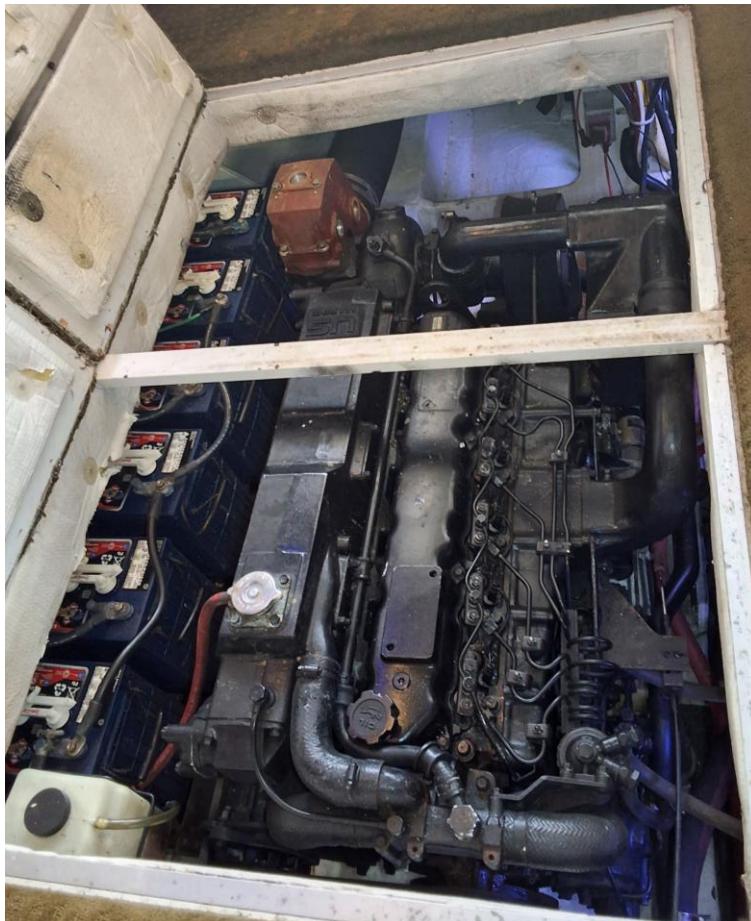
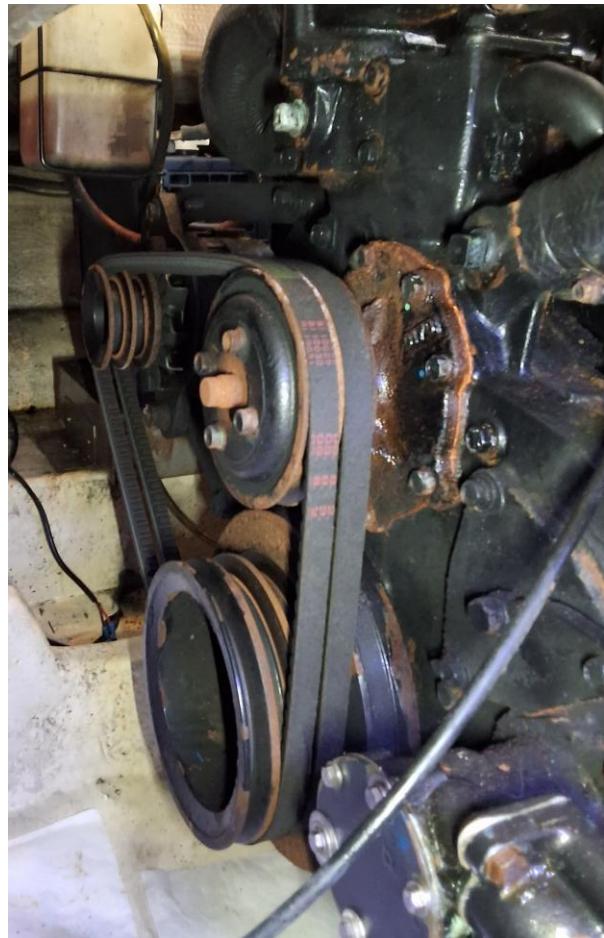
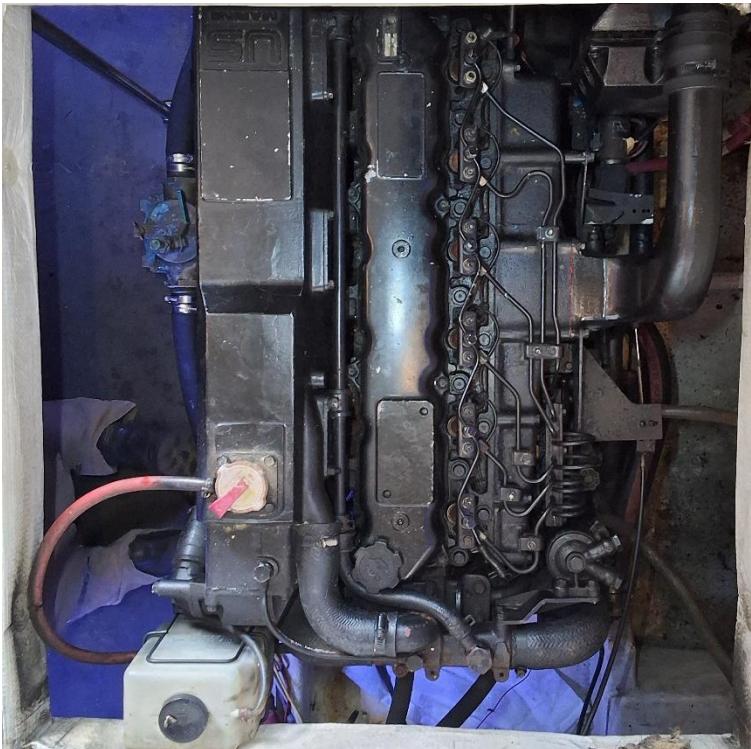
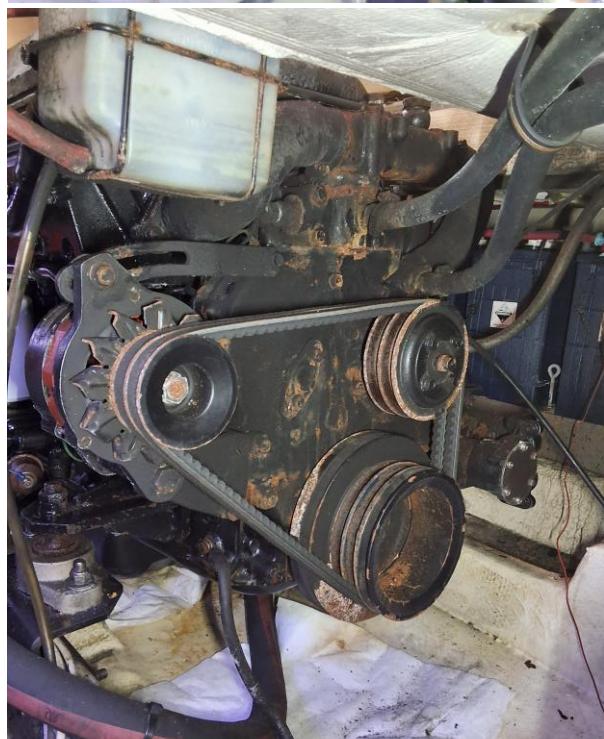
Belts & Injectors: Serpentine belts loose; soot accumulation noted around both engines. During limited operational test run, starboard engine produced smoke and odor of burnt rubber. See picture 23 & 25. *See recommendation B-3.

Picture 22 & 23 (Top Left and Right): Starboard side main engine top and front view; Picture 24 & 25 (Bottom Left and Right): Port side main engine top and front view.

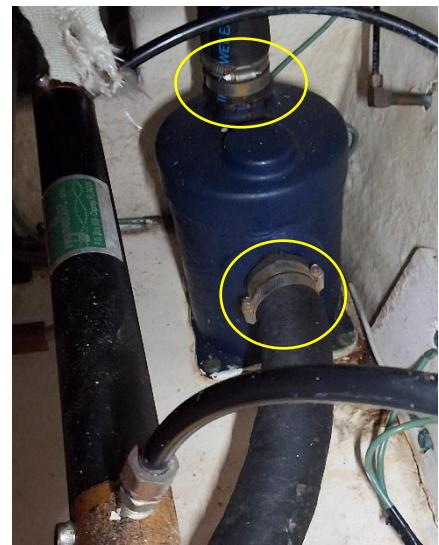
Exhaust System: Bronze outlet flanges located at outer transom port and starboard side. FRP water-lift muffler fitted and properly supported. Exhaust hose LAWRENCE marine wet-exhaust type, double-clamped at all ends; one clamp showed surface rust. See picture 27.
*See recommendation B-5.

Picture 27: Generator's exhaust hose clamps showing surface rust. Also visible is the HYNAUTIC steering cylinder.

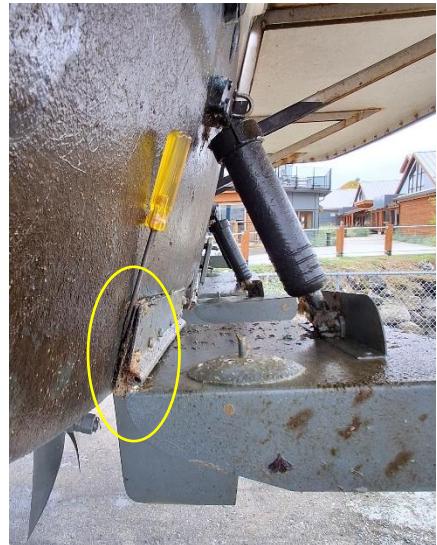
Trim Tabs: Four BENNETT hydraulic trim tabs operating in paired configuration. Tested and functional; port-side trim-tab plate partially separated at hinge. See picture 29. *See recommendation C-11.

Picture 29: Port side trim tabs partially separating at the hinge.

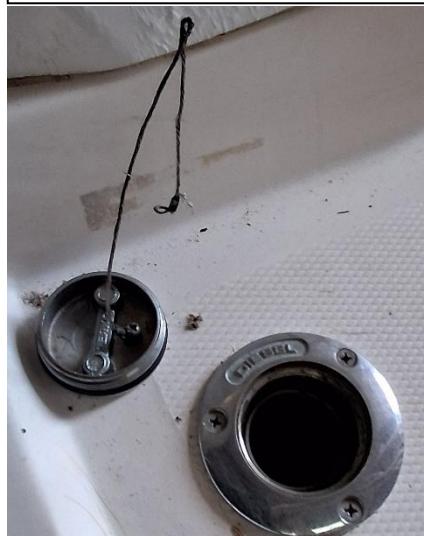
Fuel Fill System: LAWRENCE 2752 SAE J1527 Type A2 fill hoses observed, secured with stainless steel clamps and fitted with intact O-rings. Permanent "Diesel" markings visible. Starboard fill cap secured; port-side fill cap unsecured at time of inspection. Port fill hose not accessible internally. See picture 30. *See recommendation B-8.

Picture 30: Port side fuel fill cap not permanently attached.

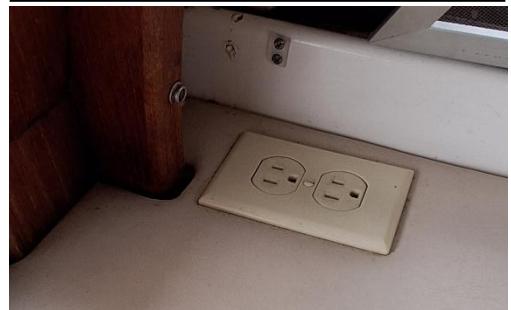
AC Receptacles: Ground-fault circuit interrupter (GFCI) outlets tested and functioning with reset capability. One receptacle installed port side at galley table, mounted horizontally facing upward on settee. See picture 34. *See recommendation C-13.

Picture 34: AC receptacle near galley table settee facing upward.

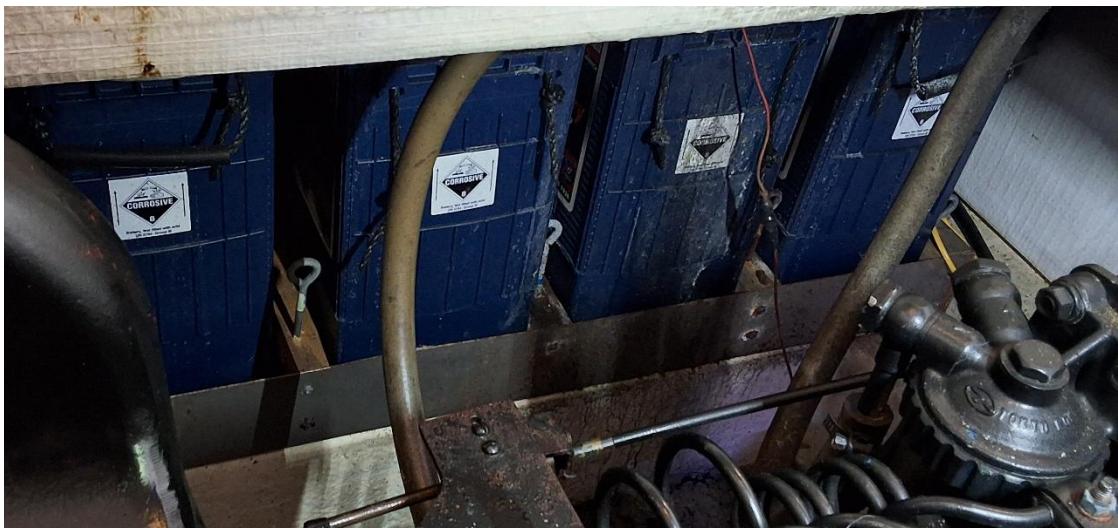
Port Battery Bank: Six 6-volt flooded lead-acid deep-cycle batteries (U.S. Battery model US-L16HC). Same rating as starboard bank. Tray contained pooled electrolyte and corrosion on wood spacers and metal eye hardware. Battery terminals displayed acid and corrosion buildup. Access severely limited; clearance between batteries and cabin sole minimal, restricting service and fluid-level checks. See picture 36. *See comment below.

Picture 36: Port side battery bank. Four of six batteries visible. Noticed battery fluid run-off on the side of the batteries. Several terminals were seen corroded.

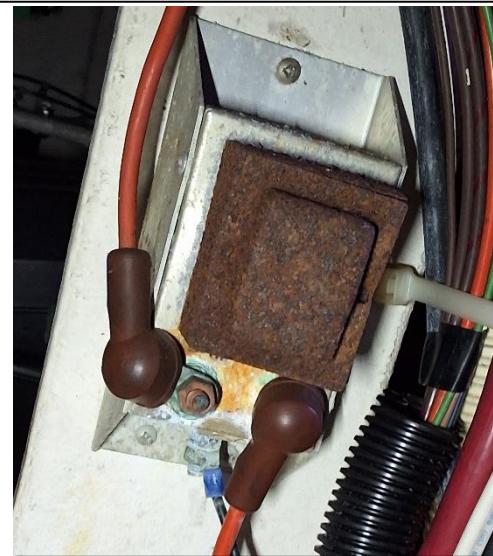
Picture 38: Battery isolator heavily corroded.

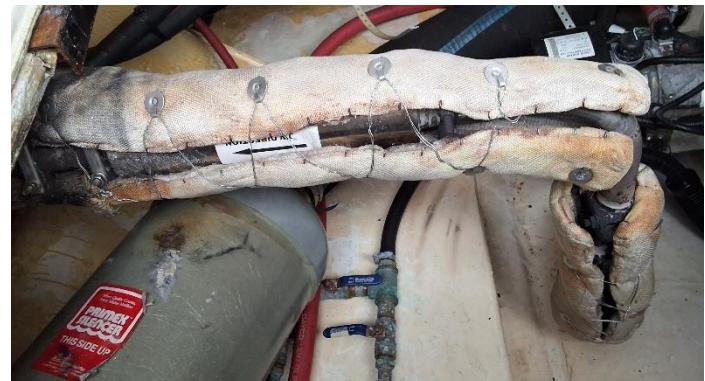
Picture 44: Port aft diesel heater with damaged exhaust insulation and rusty clamps.

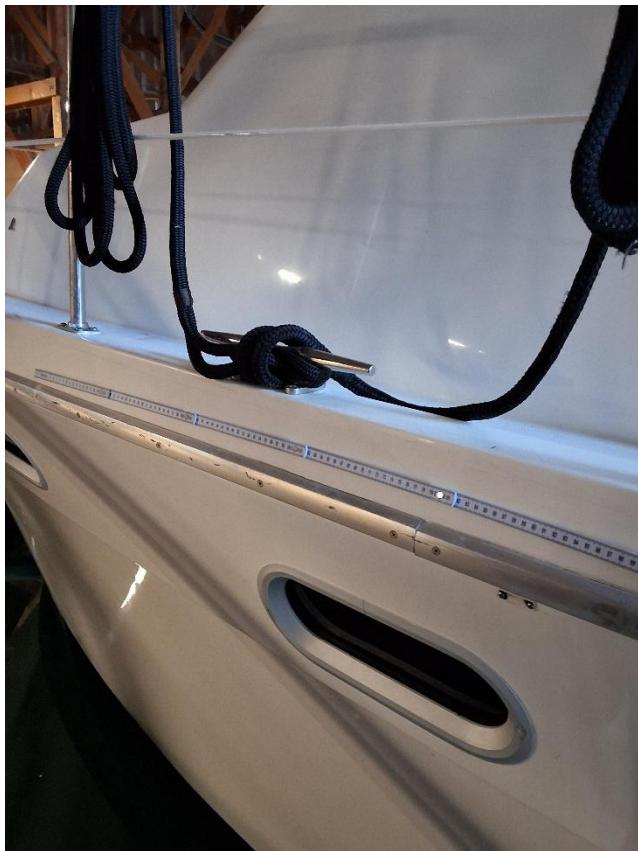
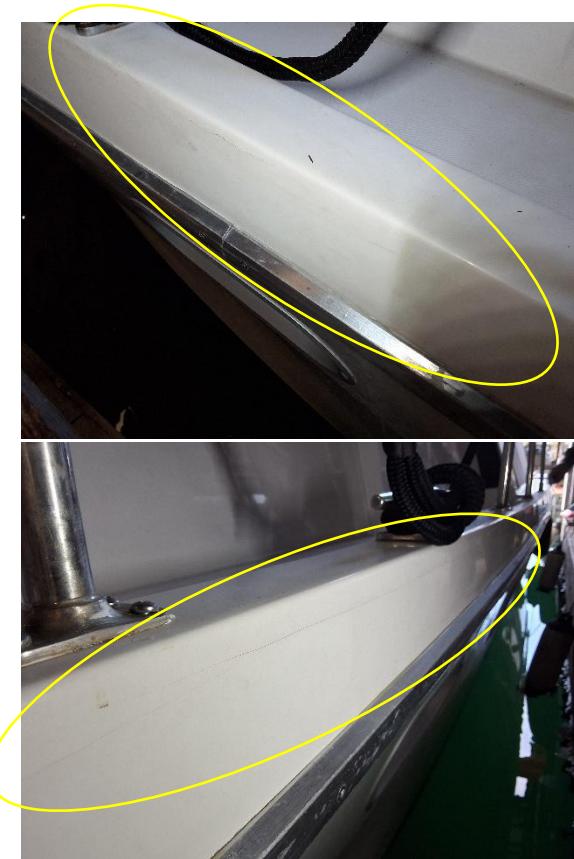
FRP Stress Cracks: Multiple surface stress cracks observed scattered throughout the vessel's deck areas. A single continuous fiberglass stress crack approximately 1.10 m (43 in) long noted on the port deck between the rub rail and cleat, extending aft toward the port access door and around the deck coaming near the cleat. The affected section exhibited signs of localized delamination surrounding the primary crack area. See appendix photo 1. *See recommendation C-2.

1) Stress cracks observed on port deck beside cleat and at port access door near rub rail (hard to see on pictures).

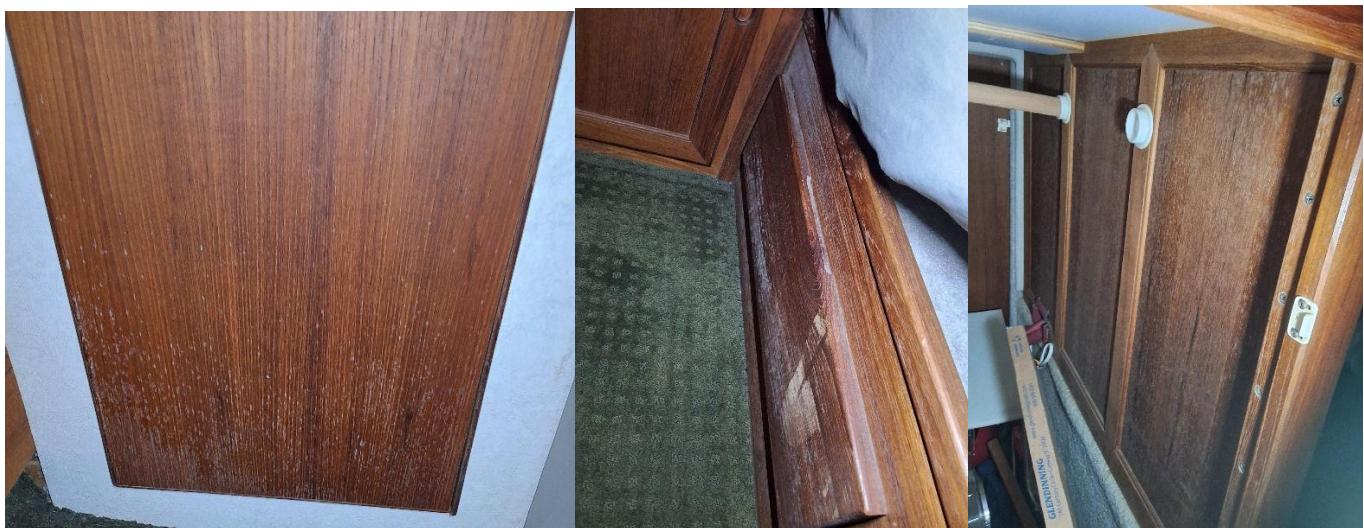
Mold and Cleanliness: Mold observed on interior wood panels within port side guest cabin's storage compartments. See appendix photo 2. *See recommendation C-5.

2) Mold visible on wooden panels inside port guest cabin area and port side storage areas.

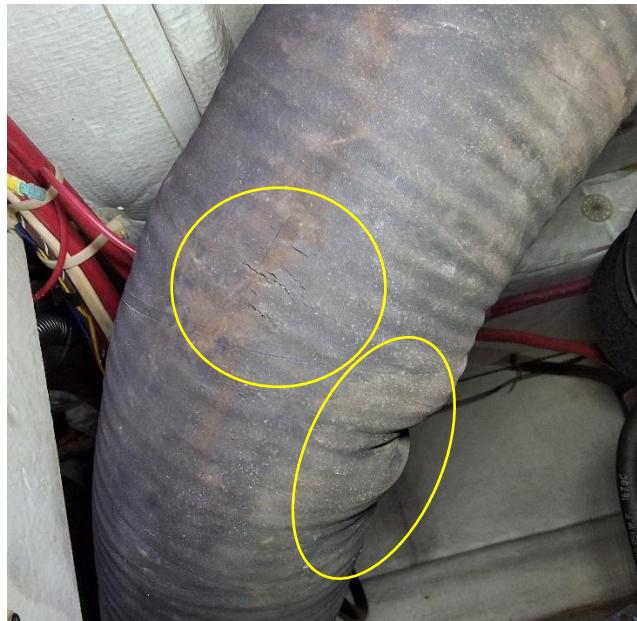
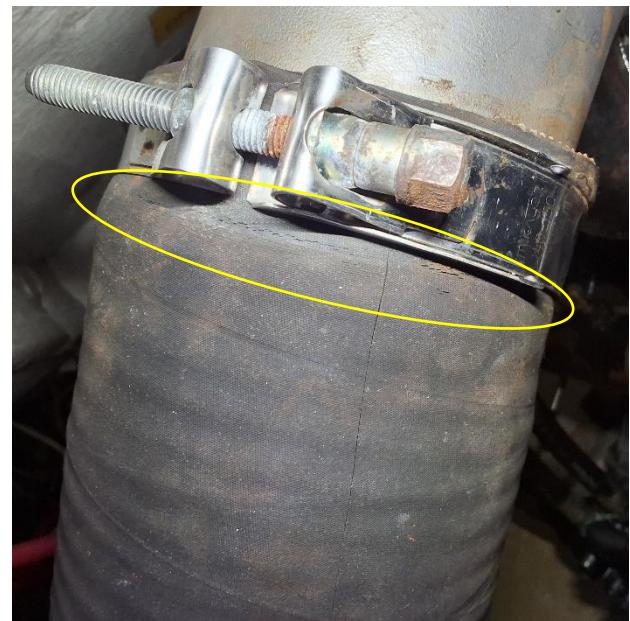
3) Port side main engine exhaust hose showing cracking at two main stress points. Also only using one single hose clamp to secure hose to elbow.

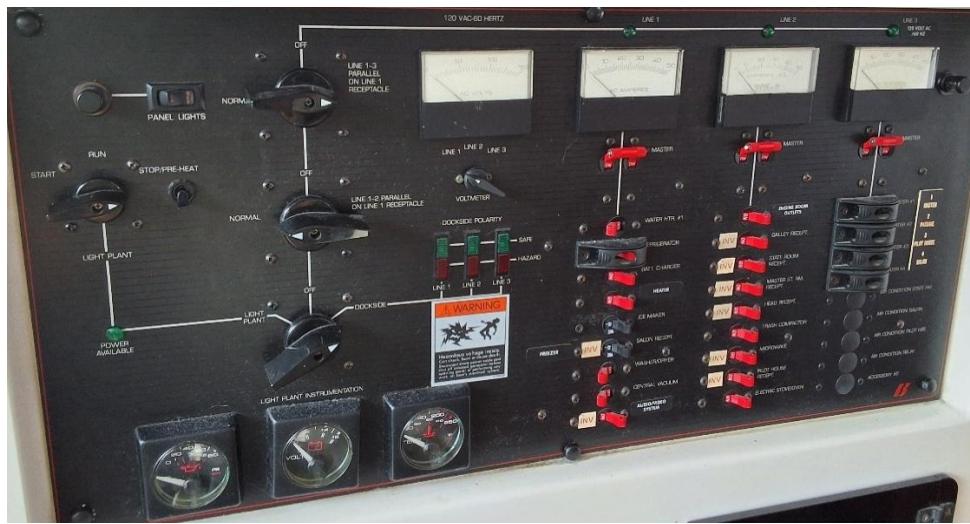
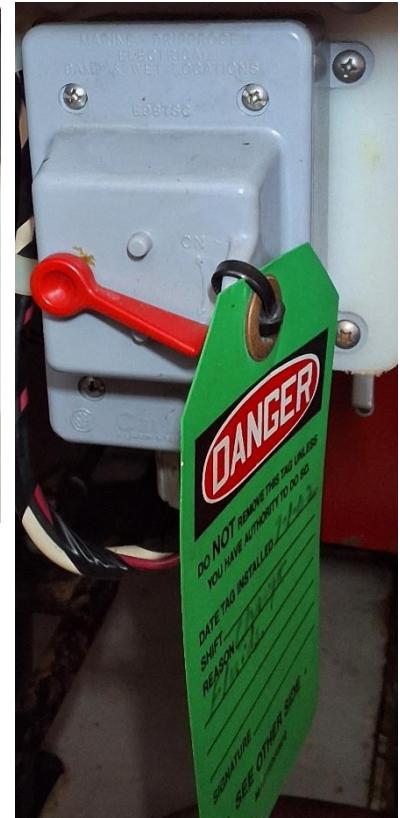
Switchboard Panel: Main AC/DC distribution panel located starboard side of cabin. Back side not accessed. AC wiring observed segregated from DC conductors. Polarity-check indicator present. Wiring of marine-grade type. One AC wet-location switch installed starboard aft in engine room, tagged "DANGER—Do Not Operate." Tag typically indicates isolation by an electrician during maintenance. See appendix photo 4. *See recommendation C-12.

4) AC switchboard panel and remote generator starting panel (Left); AC switch tagged "Danger" (Right).

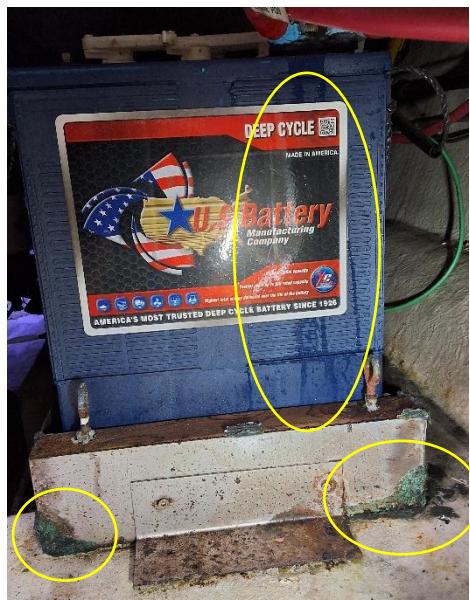
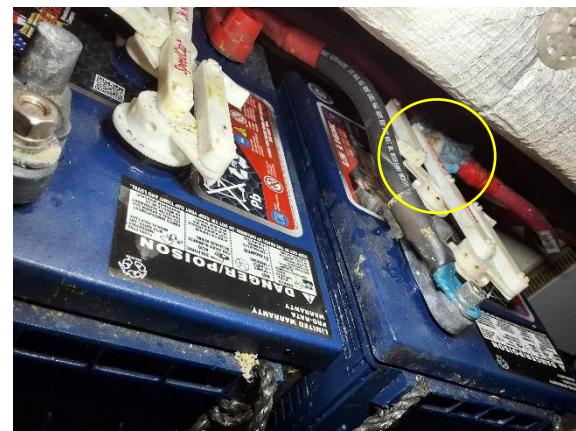
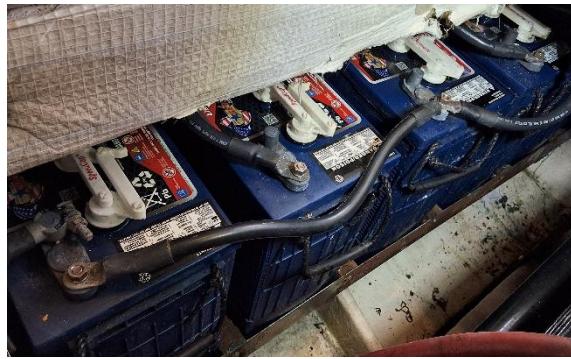
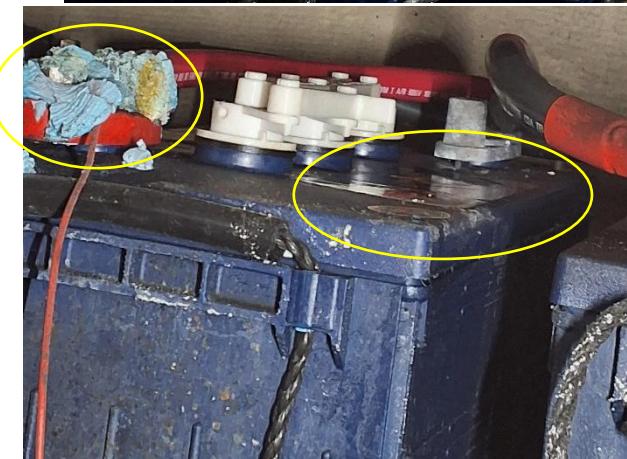
Starboard Battery Bank: Six 6-volt flooded lead-acid deep-cycle batteries (U.S. Battery model US-L16HC). Rated 420 Ah, 250 min at 75 A, and 965 min at 25 A. Batteries installed in parallel configuration. Aluminum battery tray heavily corroded with evidence of electrolyte leakage. Battery acid residue observed in bilge and throughout engine-room deck area. Several terminals exhibited corrosion buildup consistent with acid reaction on lead posts. See appendix photo 5. *See comment below.

5) Starboard side battery bank. Top left showing corrosion on battery tray. Top right photo showing corroded terminal and spilled fluid on top of the battery. Bottom left photo showing four of the six batteries. Bottom right showing remaining two batteries with corroded terminal (top right photo).

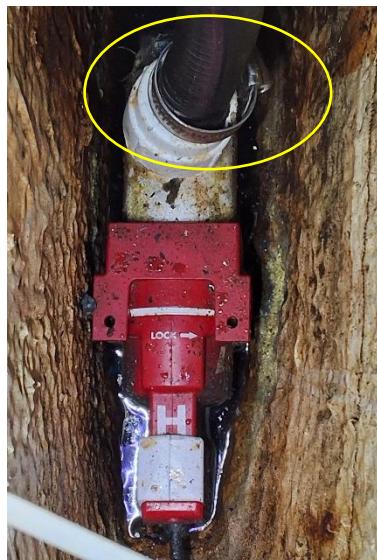
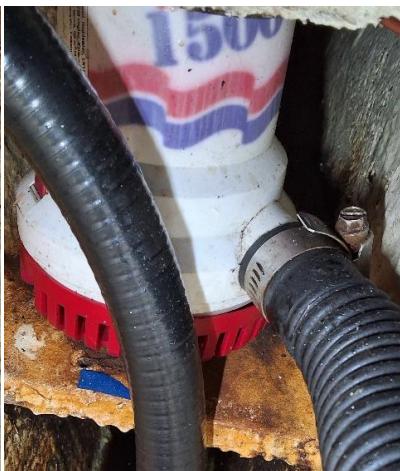
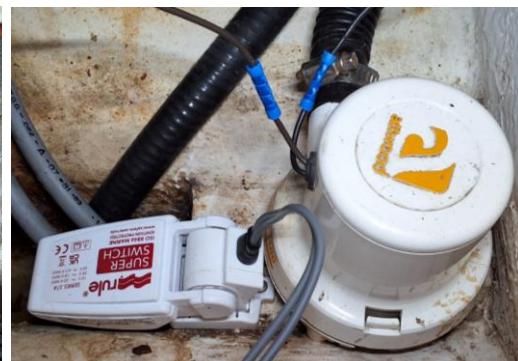
6) Three bilge pumps: (Left) RULE submersible pump. Located at lowest bilge point. Hose clamp loose on hose. (Middle) RULE 1500 mounted above submersible pump. (Right) ATTWOOD forward pump. Located below stairs amidship.
