## Sea Captain Marine Surveyor Inc.

File No: XXXX2025

### Pre-purchase Survey – (Client's name) September 2025

(Vessel's Name) is a 2002 Catalina 400 Mk II sloop, constructed in FRP with a deck-stepped aluminum mast and fin keel. The vessel is arranged with two private cabins, one forward and one aft with centerline berth, and a full galley equipped with ALDER BARBOUR refrigerator and freezer, PRINCESS LPG three-burner stove with oven, LG microwave, and KUUMA hot water tank. A VILLAGE MARINE LITTLE WONDER 200 GPD water maker is installed. Propulsion is by a YANMAR 4JH3E diesel engine rated 56 HP (41.76 kW), driving a single 1¼" stainless steel shaft through a PSS dripless stuffing box to a FLEX-O-FOLD three-blade bronze folding propeller. A MERCURY 20 HP FOURSTROKE outboard is carried for tender use.

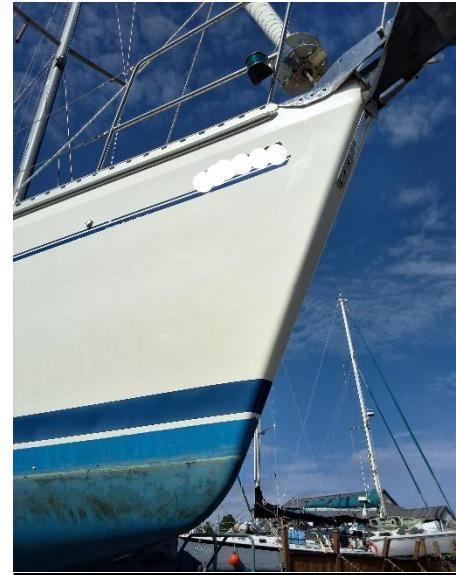
Picture 6: Leading edge of starboard bow.

**Bow Condition:** Stem and forward sections aligned; no impact or damage observed. See picture 6.

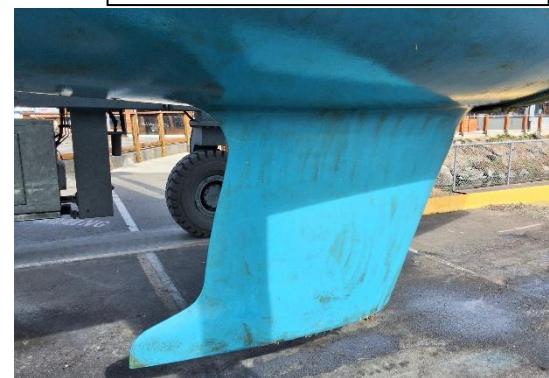
Picture 7: Starboard side view.

**Keel:** Lead cast fin keel secured by five visible keel bolts within the bilge area. Surface rust was noted on the accessible fasteners. The external keel-to-hull joint was tight, and no weeping was observed. See picture 7.

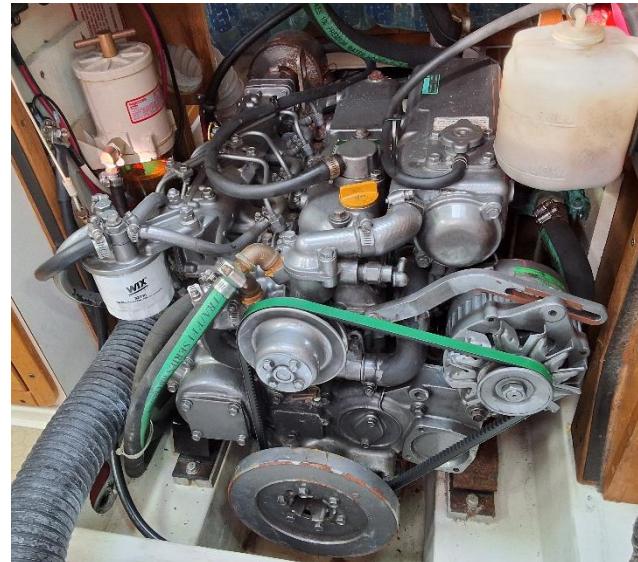
Picture 6: YANMAR 4JH3E diesel engine.

**Main Engine:** 2002 YANMAR 4JH3E marine diesel, 56 HP (41.76 kW). Engine identification plate observed; serial no: E23765. Reported engine hours approximately 2,231. See picture 6 & 7.

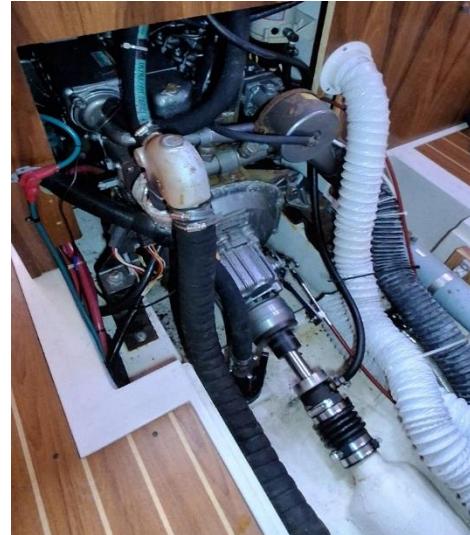
Picture 8: KANZAKI transmission with PSS shaft seal.

**Stuffing Box:** PSS shaft seal type; observed dry with no leakage at time of inspection. See picture 8.

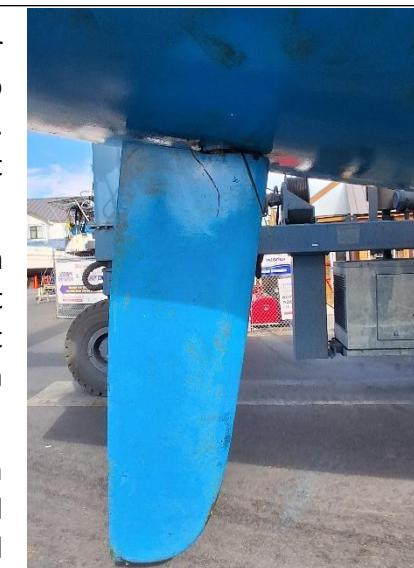
Picture 11: Starboard view of spade rudder.

**Rudder:** Spade rudder; movement firm with no excessive play or looseness detected. Moisture testing conducted with a TRAMEX moisture meter indicated dry readings throughout the rudder blade. No gelcoat blisters or surface deformation observed. Percussion testing produced clear, solid tones, consistent with sound laminate structure. See picture 11.

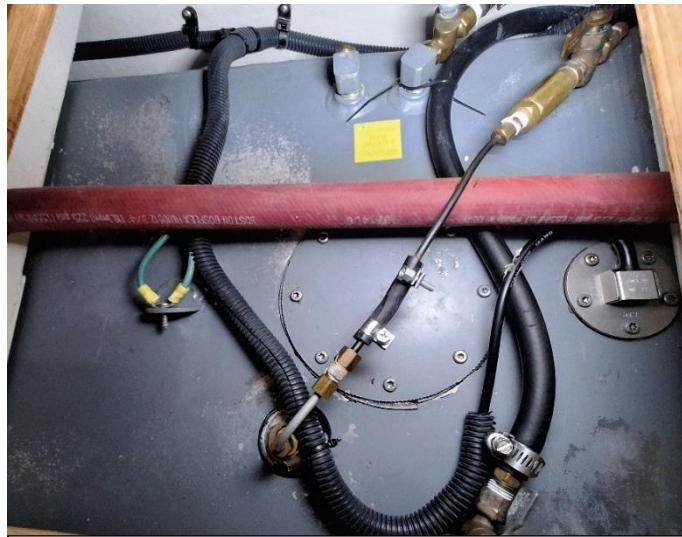
Picture 12: Diesel fuel tank with shut-off valve and fuel vent (top right).

**Fuel Tanks:** One aluminum fuel tank, located aft under berth. Capacity approximately 35 US gallons (132 L). Internal inspection through access ports possible. No ID plate visible, Tank grounded with bonding wire. No signs of corrosion or leakage observed on accessible surfaces. See picture 12.

**Fuel Vent System:** Stainless steel vent with flame screen fitted port side aft on hull topsides; hose connections secure. See picture 12.

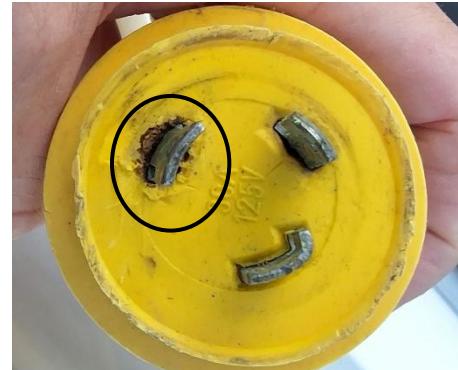
**Shore Power Connection:** One 30A/125V shore power inlet located port side aft. Backside protection in place; however, one cable terminal showed evidence of burning and arcing, requiring replacement. See picture 13. **\*See recommendation B-2.**

Picture 13: Shore Power cable plug with damaged terminal.

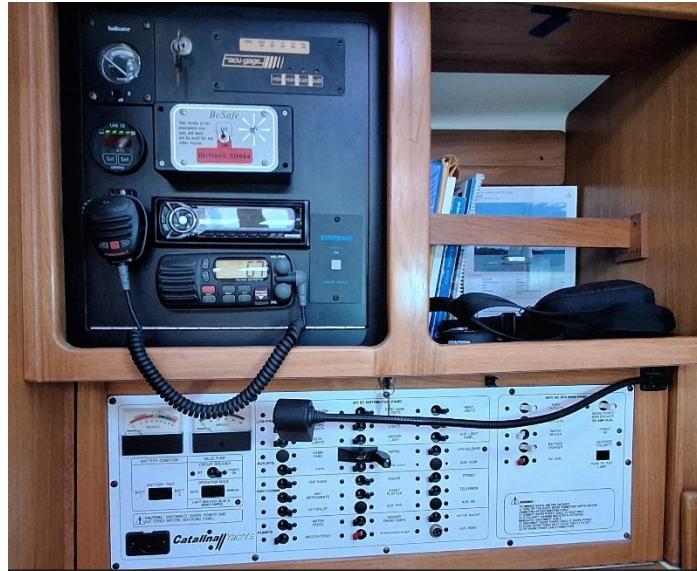
Picture 14: AC/DC switchboard Panel.

**Main Breaker & Switchboard:** CATALINA factory AC/DC switchboard located in saloon. The AC system was protected by a 30A double-pole main breaker located within the switchboard in compliance with

ABYC E-11 standards. Breakers properly labeled, polarity test lamp fitted, and no doubled circuits observed. See picture 14.

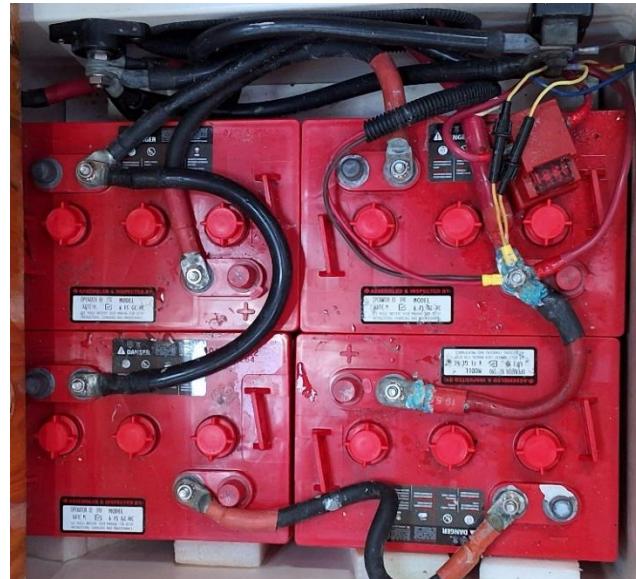
**House Bank:** Four ROLLS 6FS-6V GC-HC deep-cycle flooded lead-acid batteries configured as a 12 V DC house bank. Installed in a dedicated compartment beneath the cabin sole in front of the engine mid-ship. Containment arrangement secure with no lateral movement observed, and no signs of electrolyte spillage at the time of survey. Compartment fitted with natural ventilation. Batteries were not restrained against vertical movement. See picture 16. \*See recommendation B-3.

**Condition:** Both battery installations are properly secured, with containment adequate for their type. Connections are serviceable, though light terminal corrosion observed on portions of the house bank cabling.

Picture 16: ROLLS battery bank. Not restrained from vertical movements.

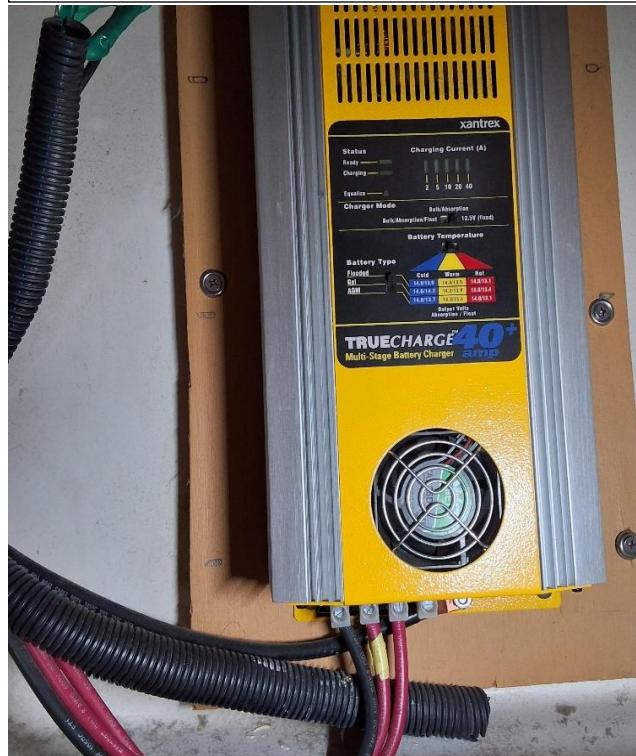
Picture 17: XANTREX battery charger.

**Battery Charger:** XANTREX TRUECHARGE 40+ multi-stage battery charger, 40A output. Outer case grounded and securely mounted. Wiring connections properly fused and protected. Located on the port side below the chart table inside a storage compartment. The unit was energized and observed in operation during the survey, delivering a steady charging voltage of approximately 13.6 VDC, consistent with proper absorption or float-charge output. See picture 17.

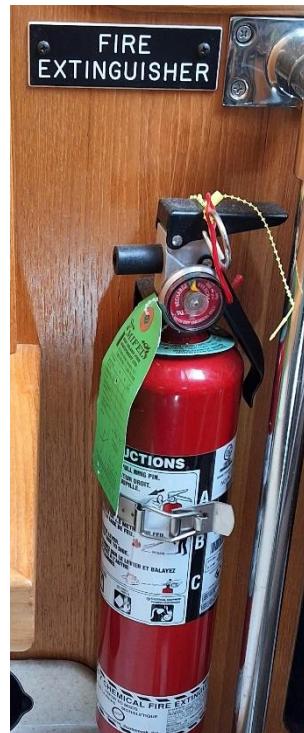
**Fire Extinguishers:** Three (3) portable ABC dry chemical extinguishers, all properly mounted and identified at bow, galley, and aft cabin. Last inspection dated March 2023 with service due March 2024. Extinguishers are now expired and require immediate replacement or servicing. \*See recommendation A-2.

Picture 20: Fire extinguisher with location tag.

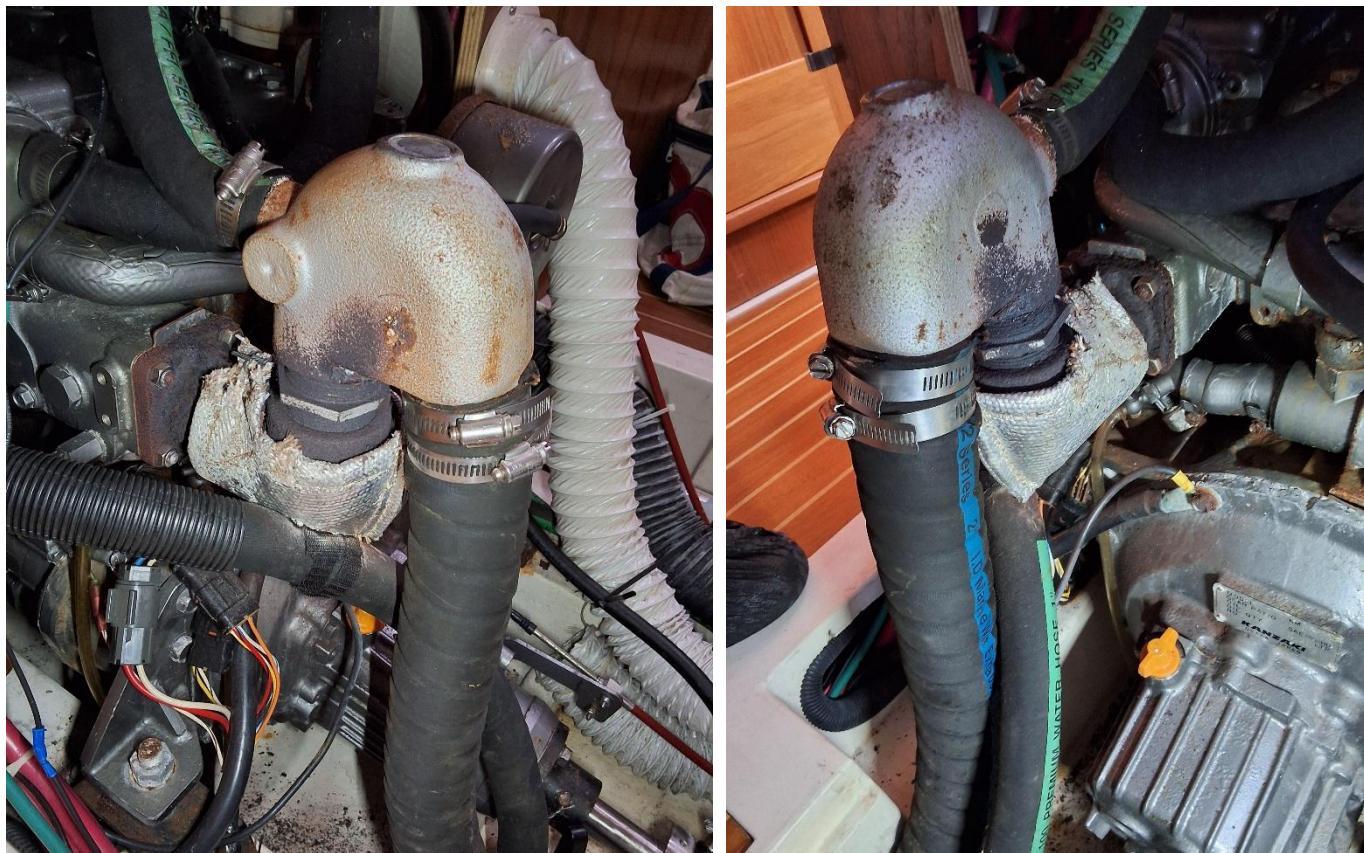
**Exhaust System:** Exhaust elbow located at the engine outlet constructed of cast iron with an upward bend and partial thermal insulation covering. Surface rust and soot accumulation observed at the outlet flange. The exhaust system was fitted with SAE J2006-rated marine wet exhaust hose in serviceable condition, secured with double stainless steel clamps at all connections. An ULTRA Marine Products silencer was installed in-line. The mechanic from *DDM - Dynamo Diesel & Marine* reported that new exhaust components have been ordered, with replacement scheduled. See appendix photo 1. \*See recommendation B-1.

- 1) YANMAR exhaust elbow showing soot and rust.
