## Sea Captain Marine Surveyor Inc.

File No: XXXX2025

### Pre-purchase Survey – (Client's name) September 2025

(Vessel's Name) is a 2002 Catalina 400 Mk II sloop, constructed in FRP with a deck-stepped aluminum mast and fin keel. The vessel is arranged with two private cabins, one forward and one aft with centerline berth, and a full galley equipped with ALDER BARBOUR refrigerator and freezer, PRINCESS LPG three-burner stove with oven, LG microwave, and KUUMA hot water tank. A VILLAGE MARINE LITTLE WONDER 200 GPD water maker is installed. Propulsion is by a YANMAR 4JH3E diesel engine rated 56 HP (41.76 kW), driving a single 1¼" stainless steel shaft through a PSS dripless stuffing box to a FLEX-O-FOLD three-blade bronze folding propeller. A MERCURY 20 HP FOURSTROKE outboard is carried for tender use.

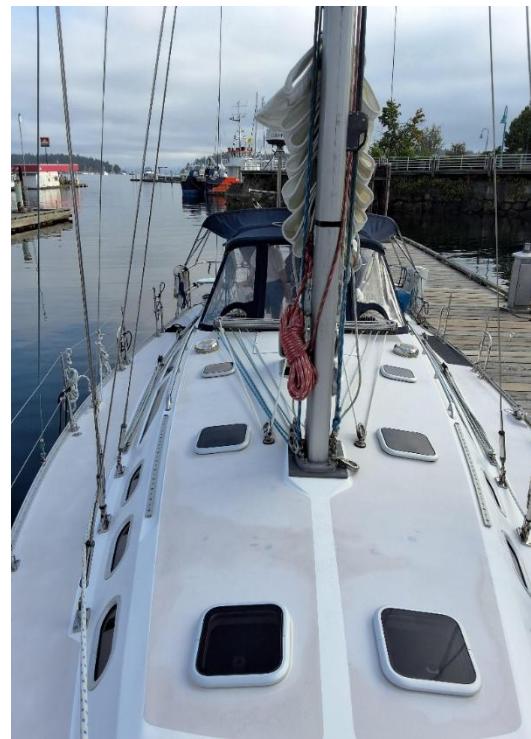
**Windows & Portholes:** Acrylic side windows and deck hatches noted with surface crazing/grazing on most side windows; sealing intact.

Picture 5: Deck, mast and deck hatches.

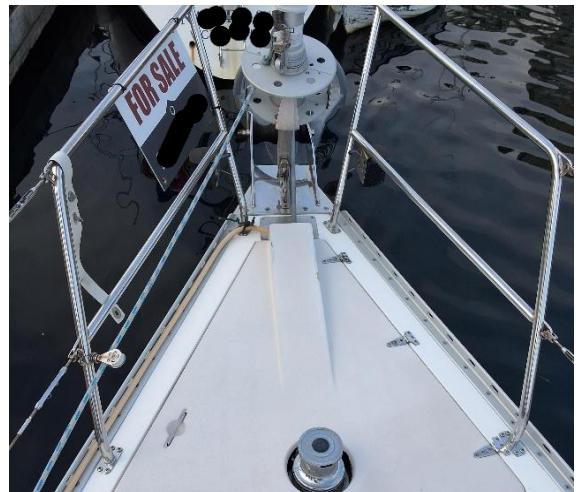
- **Primary Anchor:** 25 kg ROCNA anchor with stainless steel swivel; bitter end properly secured.
- **Rode:** 200 ft of 5/16" high-tensile chain marked G4 and 250 ft of three-strand nylon rode.
- **Windlass:** Electric MAXWELL VW800 unit with foot operated controls at the bow, operational during survey.

Picture 7: Anchor locker bow hatch with windlass and headsail Furler.

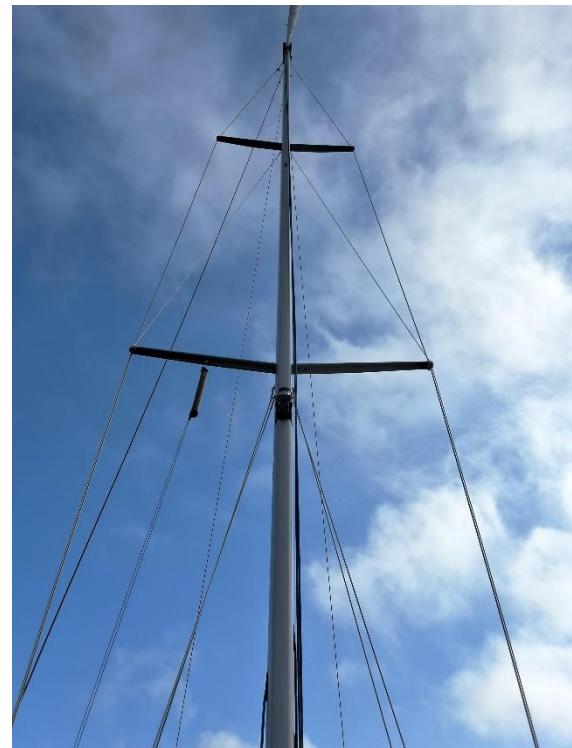
**Mast:** Fitted with an aluminum sloop rig, deck stepped. No corrosion, deformation, or stress marks observed on the mast section. The mast was inspected from deck level only; internal halyards, masthead fittings, and wiring were not accessed. The mast step was deck-stepped, secure, with no visible cracks, movement, or deformation. Aluminum compression post stepped on a reinforced base.

**Standing Rigging:** 1x19 stainless steel wire construction, consisting of 3/8" forestay, backstay, and upper shrouds, and 5/16" lower forward and aft shrouds in bridle configuration. Swaged fittings appeared secure with no bends, rust, or cracks, and all cotter pins were in place. The service date and installation age of the standing rigging were unknown, and it could not be confirmed whether the rigging was original.

Picture 8: Mast, spars, radar reflector and rigging looking aft.

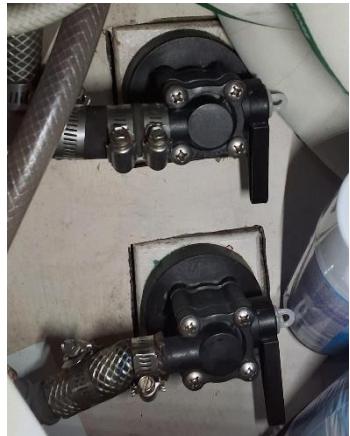
**Comment:** All PVC and stainless steel fittings located above the waterline are subject to degradation from ultraviolet exposure and saltwater environment. These components have a limited-service life and should be inspected regularly and replaced as required to maintain watertight integrity.

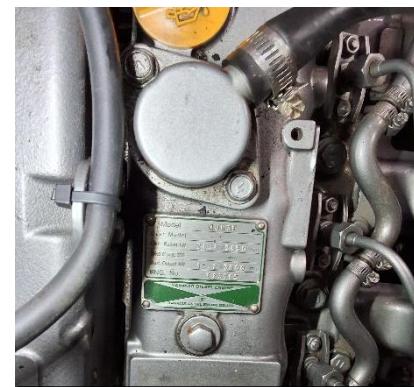
**Main Engine:** 2002 YANMAR 4JH3E marine diesel, 56 HP (41.76 kW). Engine identification plate observed; serial no: E23765. Reported engine hours approximately 2,231. See picture 6 & 7.

Picture 7: Engine ID plate.

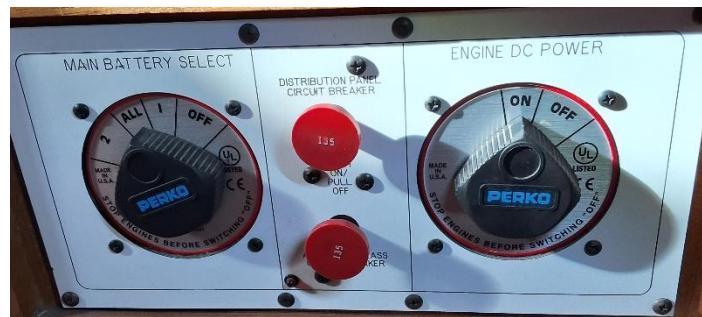
Picture 15: Dual PERKO battery switch

bulkhead. The installation is easily accessible from outside the engine space, allowing safe operation without entering the machinery area.

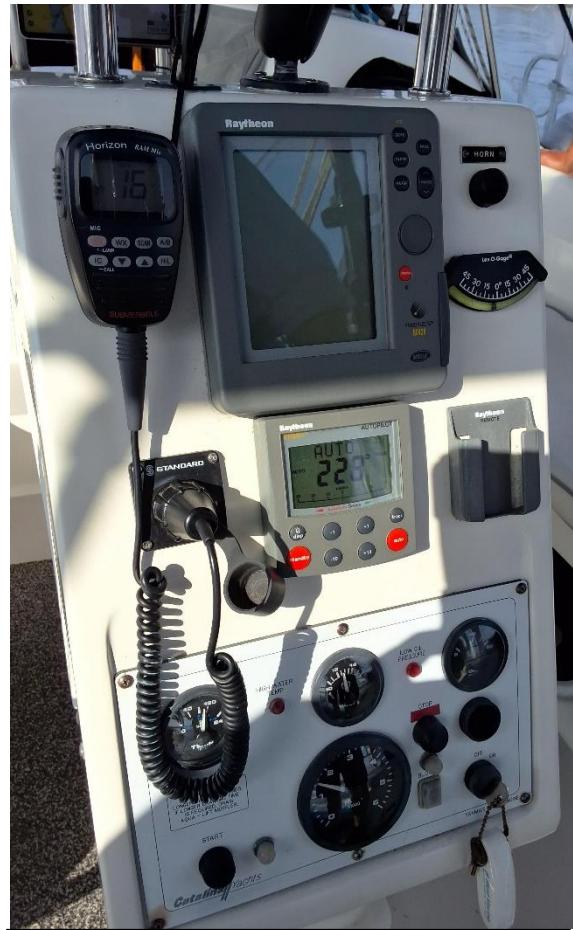
Picture 18: Helm instruments in cockpit.

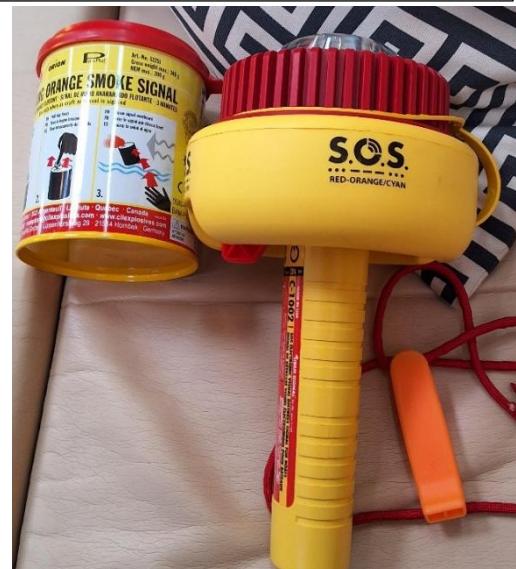
Picture 19: Electric SOS distress light and orange smoke canister.

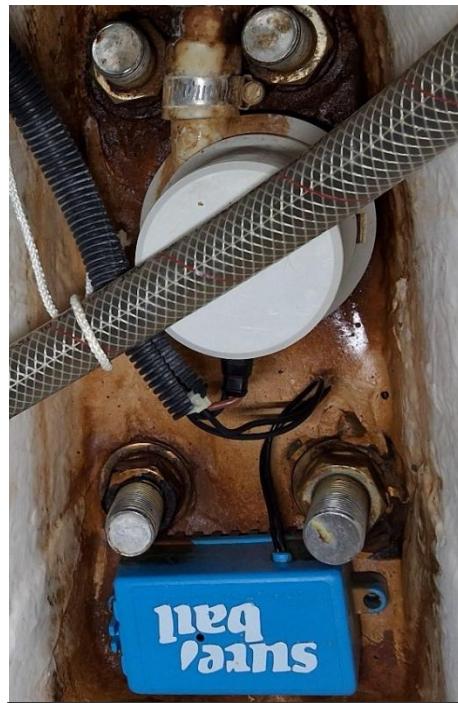
**Automatic Pump:** RULE 2000 GPH electric bilge pump installed with SURE BAIL float switch, located in bilge sump. Wired direct to battery with fused circuit and manual/auto helm switch. Electric bilge pump energized and tested during the survey. The pump motor operated normally when activated; however, the system was not tested with water in the bilge, so actual discharge flow and pumping performance were not verified. See picture 21.

Picture 21: RULE 2000 bilge pump with SURE BAIL float switch.

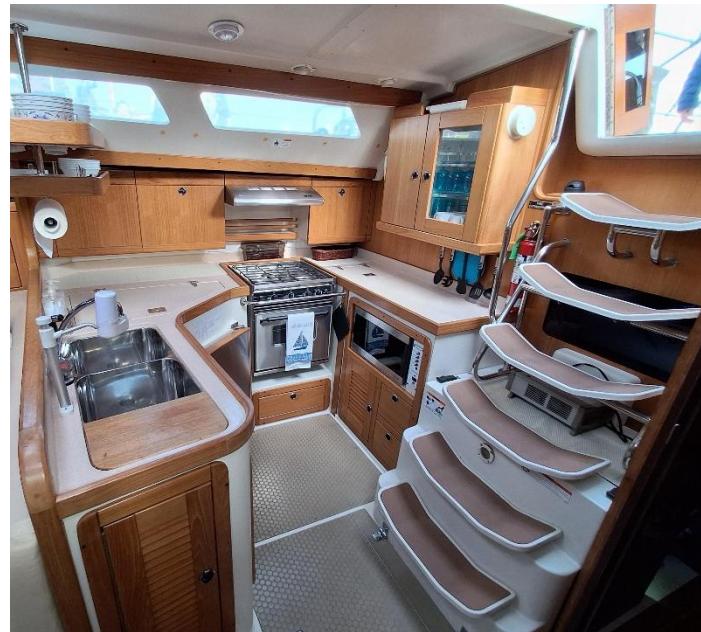
Picture 22: Port side view of galley.

**Cooking Appliances:** PRINCESS LPG three-burner stainless steel gimbaled stove with oven. Hose condition observed serviceable, protected where going through bulkhead. Does not restrict stove movement. No cracking noted. Oven and burners operational at time of survey.

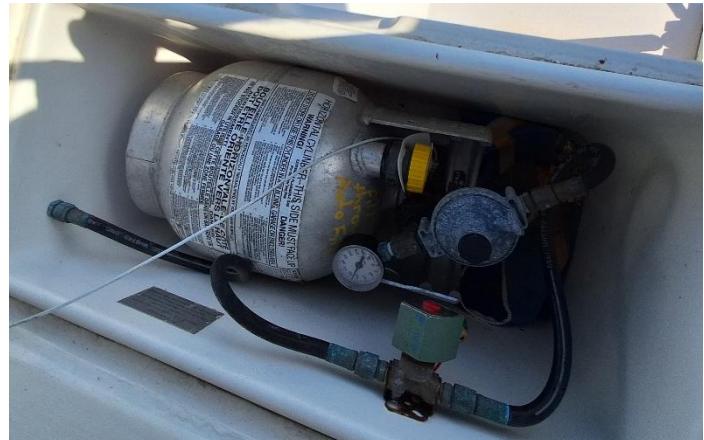
**Propane System:** One (1) aluminum propane cylinder of unknown capacity located in a dedicated starboard stern transom locker. Locker vented overboard and fitted with a pressure gauge, regulator, solenoid, and manual shutoff valve. Solenoid switch located at the galley panel; switch and indicator light were tested and found operational. A three-minute leak-down test was performed with no pressure loss observed, confirming system integrity. See picture 23.

Picture 23: Propane cylinder within a dedicated propane locker located at the starboard transom.

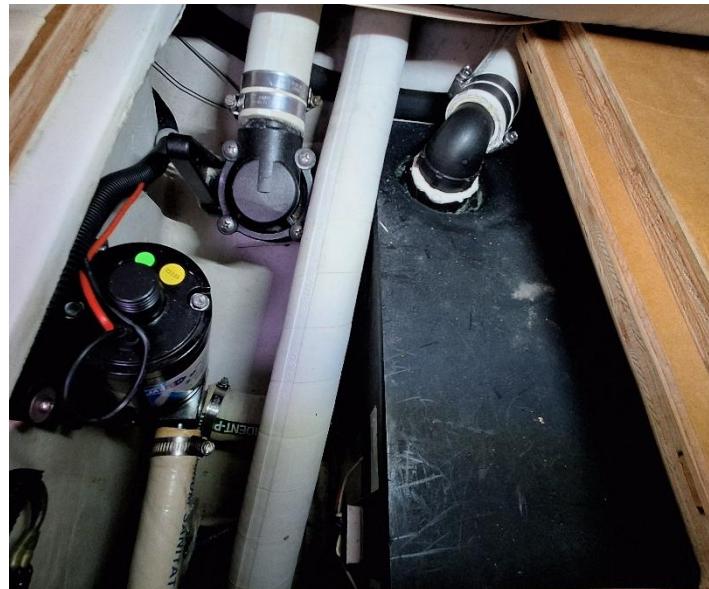
**Sewage Tank:** Two polyethylene black holding tank, total capacity approximately 25 gallons (94.6 liters). One (1) located port side mid-ship under settee and one (1) located starboard side under seating settee. Hose and connection points intact with no active leaks observed. See picture 21.

Picture 24: Black sewage tank with JABSCO macerator pump located port side mid-ship.

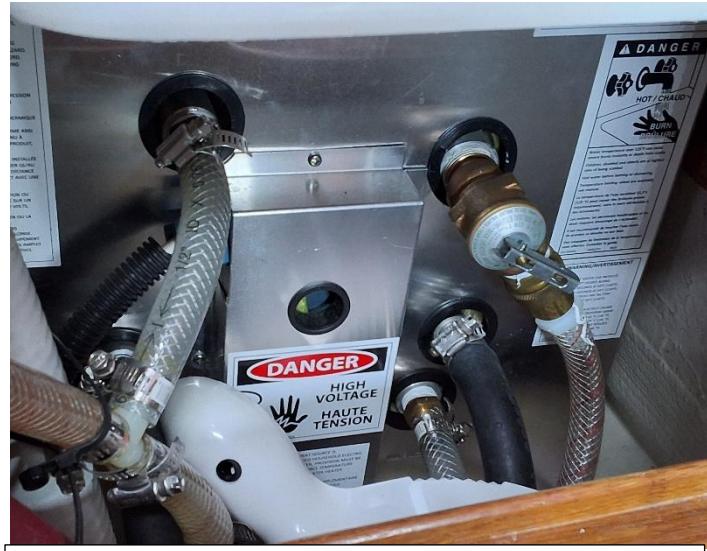
**Hot Water Tank:** KUUMA 6-gallon (22.7 liters) marine water heater, ignition protected, UL-listed. Unit connected to both 120V AC shore power and engine heat exchanger. Located in galley compartment. See picture 25.

Picture 25: KUUMA hot water tank.

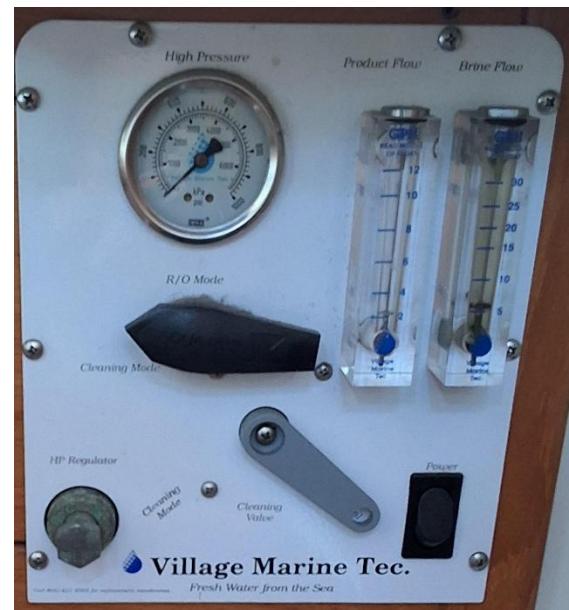
**Desalinator:** VILLAGE MARINE LITTLE WONDER 200 GPD unit fitted. Not tested as cylinder housing has been reported to have a hairline crack requiring replacement prior to safe operation. See picture 26. **\*See recommendation C-3.**

Picture 26: VILLAGE MARINE TEC. desalinator.
